DDAS Accident Report

Report date: 21/06/2008	Accident number: 581
Accident time: 07:58	Accident Date: 21/11/2007
Where it occurred: MF: A-Kurmuk, M/F NR 91, DA NR 286.	Country: Sudan
Primary cause: Field control inadequacy (?)	Secondary cause: Management/control inadequacy (?)
Class: Missed-mine accident	Date of main report: 05/12/2007
ID original source: None	Name of source: UNMAO Sudan
Organisation: [Name removed]	
Mine/device: PRB M35 AP blast	Ground condition: bushes/scrub dry/dusty sparse trees
Date record created:	Date last modified: 21/06/2008
No of victims: 1	No of documents: 2

To Inquire Into The Circumstances Under Which [the Victim] Of [Demining group] Got Injured (Left Foot Heel) On 21 November 2007 In Minefield Area Due To The Mine Blast.

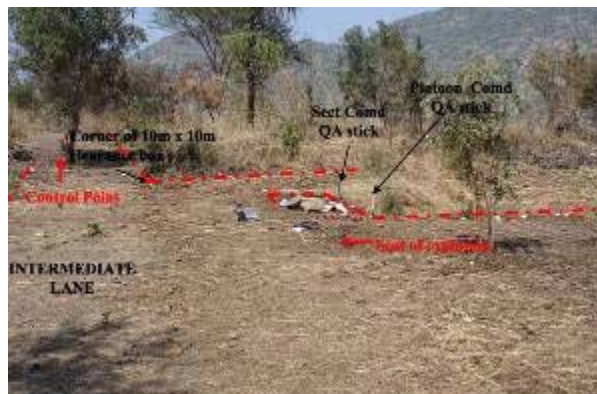
[The accident site after post-accident marking had been removed.]

Scene of Accident: When the PIT arrived at the scene of the accident there was initially a great deal of confusion and concern. The site marking encountered indicated that the specific spot of the accident had occurred within a hazardous area. After consultation and discussion with relevant appointments of the [Demining group]-II, it was determined that the scene of the accident had been interfered with and the marking stones moved. Following instructions from the NQAC, the site marking was restored.

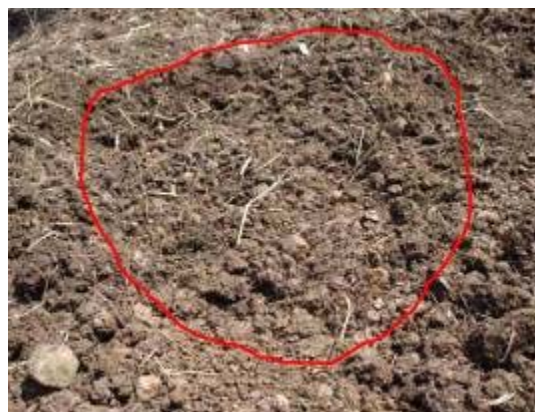
[The "crater" before excavation.]

The site was severely disrupted after the accident, presumably in the attempt to avoid censure. The disruption included moving the marking and the apparent levelling of the crater. AP mine blasts do not leave level loose ground that must be dug out to determine the depth of ground disturbance. Digging did not confirm the depth at which the mine had detonated. It did confirm that the undisturbed ground marked the depth of the original excavation, proving that the ground was not processed to the required depth during clearance. Because disturbed ground has more bulk than compacted ground, the actual depth of clearance was probably less than that measured.

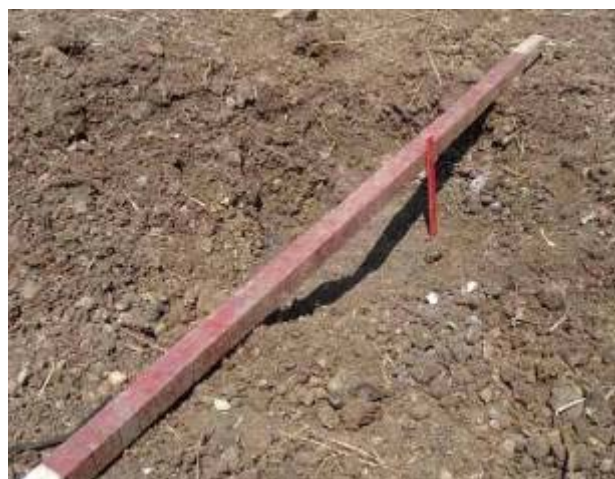
[The crater after excavation. See Analysis.]

4.1.1.2 That, from the investigation of the seat of the explosion, the floor of the crater caused by the explosion was at 18 cm below the surrounding ground level.

4.1.1.4 That, from an investigation of areas randomly chosen and within the immediate vicinity of the accident spot, required clearance depths were found to have been achieved i.e. 15cm.
